RUBICON FRONT BUMPER

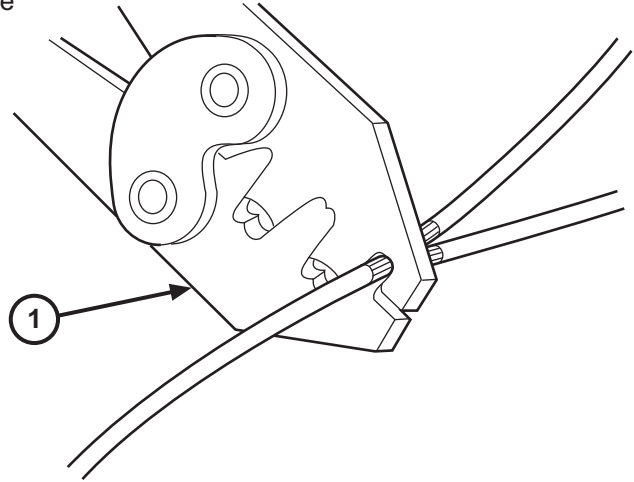
4. Using a crimping tool (1) (MOPAR Part Number 05019912AA, Miller Special Tool Number or equivalent) crimp the splice band and wires together securely.

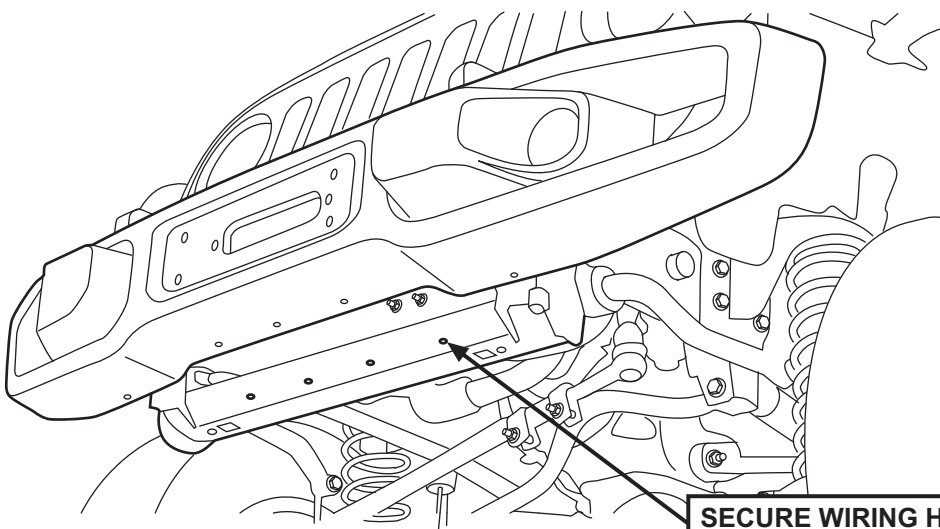
8

SECURE WIRING HARNESS CLIPS TO HOLES INSIDE BEAM
